Five-Year Review Report
Second Five-Year Review Report
for
N. W. Mauthe Superfund Site
Appleton
Outagamie County, Wisconsin
April 2006

Wisconsin Department of Natural Resources
Jennifer Borski, Hydrogeologist
625 E Cty Rd Y, STE 700
Oshkosh, Wisconsin 54901-9731

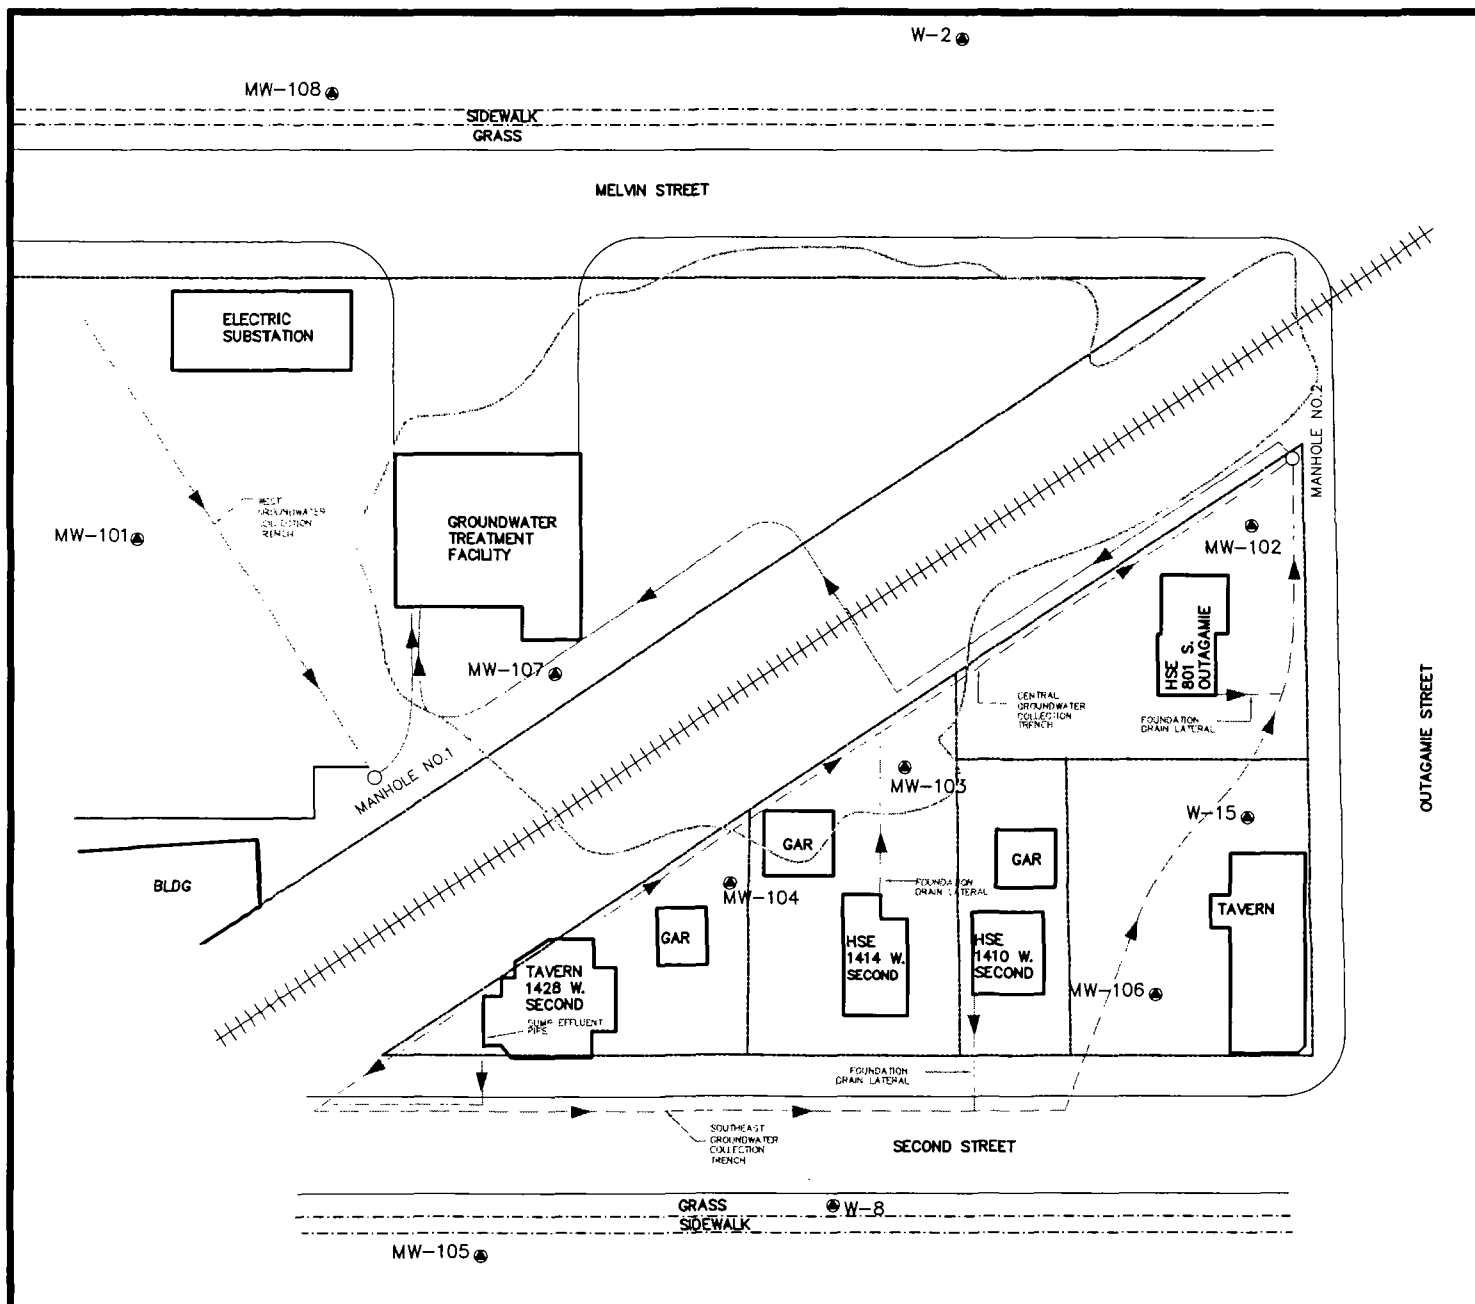
FIGURE 4
ISOCONCENTRATION MAP
TOTAL CHROMIUM ug/L in Groundwater
DECEMBER, 2006
N.W. MAUTHE SUPERFUND SITE

Chromium at MW-107 has generally been stable over the past five years and since 1997 with the exception of a spike in concentration in 2000. Over the past five years, chromium ranged from 8,200 ug/L in June 2001 to 2,400 ug/L in December 2005. A concentration verses time graph for chromium at MW-107 is included in Appendix E. A chromium iso-concentration map for December 2005 is shown on Figure 4 in Appendix A.

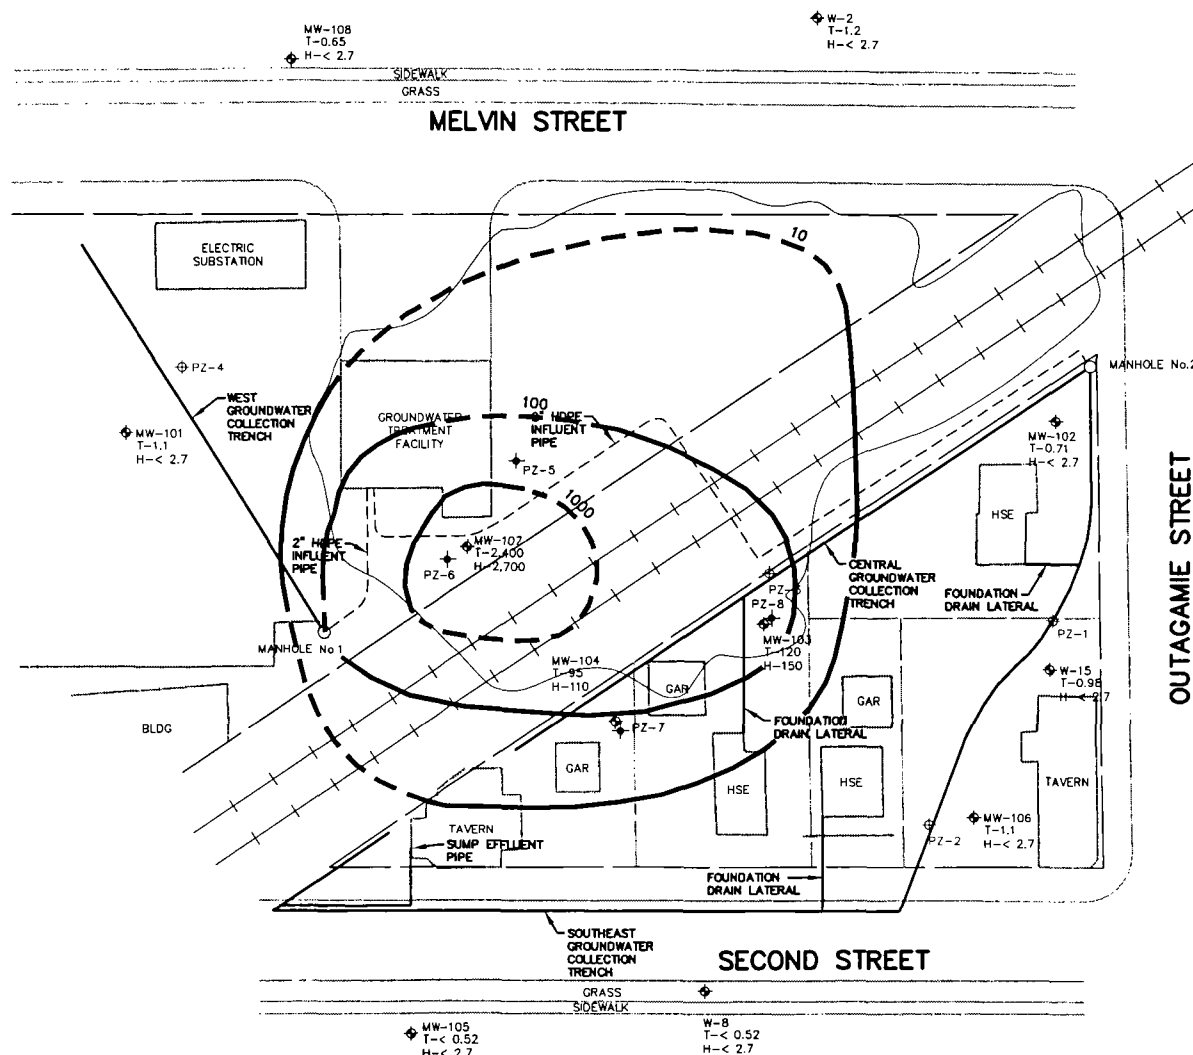
The excavation of an area identified as a hot spot served to remove a majority of the source area and was excavated between July and October 1995. An area with soils greater than 500 mg/kg was identified as the hot spot. Additional soils were excavated on and off-site to access the soils identified for removal. Excavated soils greater than 50 mg/kg were transported off-site for proper disposal. Excavated soils less than 50 mg/kg were replaced onsite along with clean soils. Two feet of clay and a vegetative cover were installed in June 1996. The excavation area is shown on Figure 2 in Appendix A.

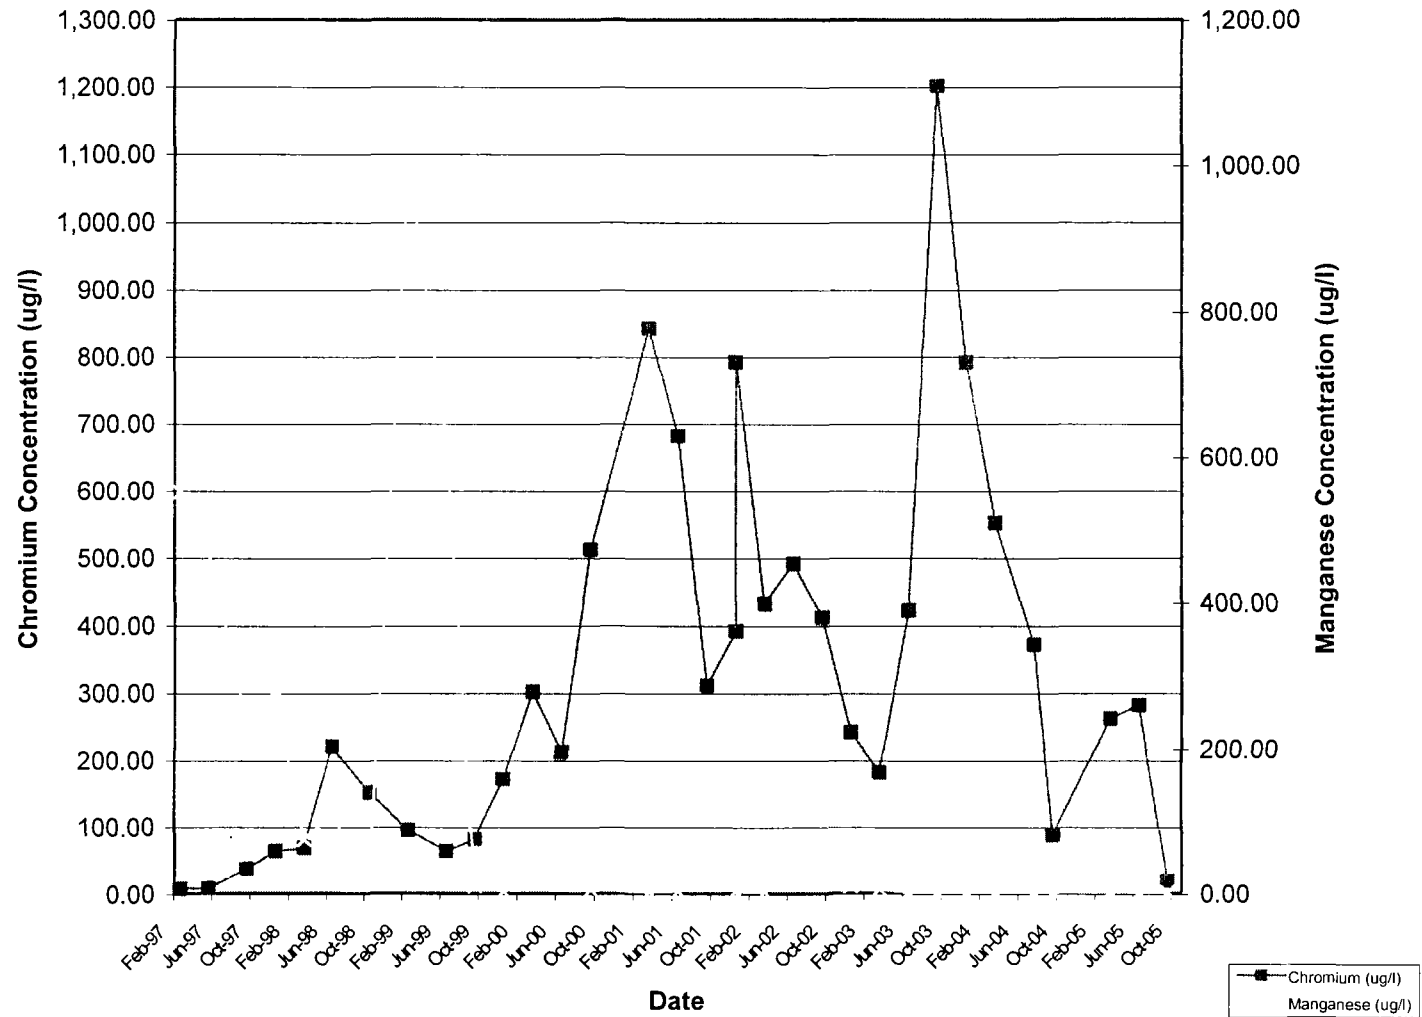
MW-104 / Time vs. Concentration

Mr. Much noted that the sample from MW-104 during December 2005 was very turbid and silt and sand were present in the well. This may be due to installation of PZ-7 in June 2005. Mr. Much will note the turbidity of the sample in March 2006 and discuss with Ms. Borski.

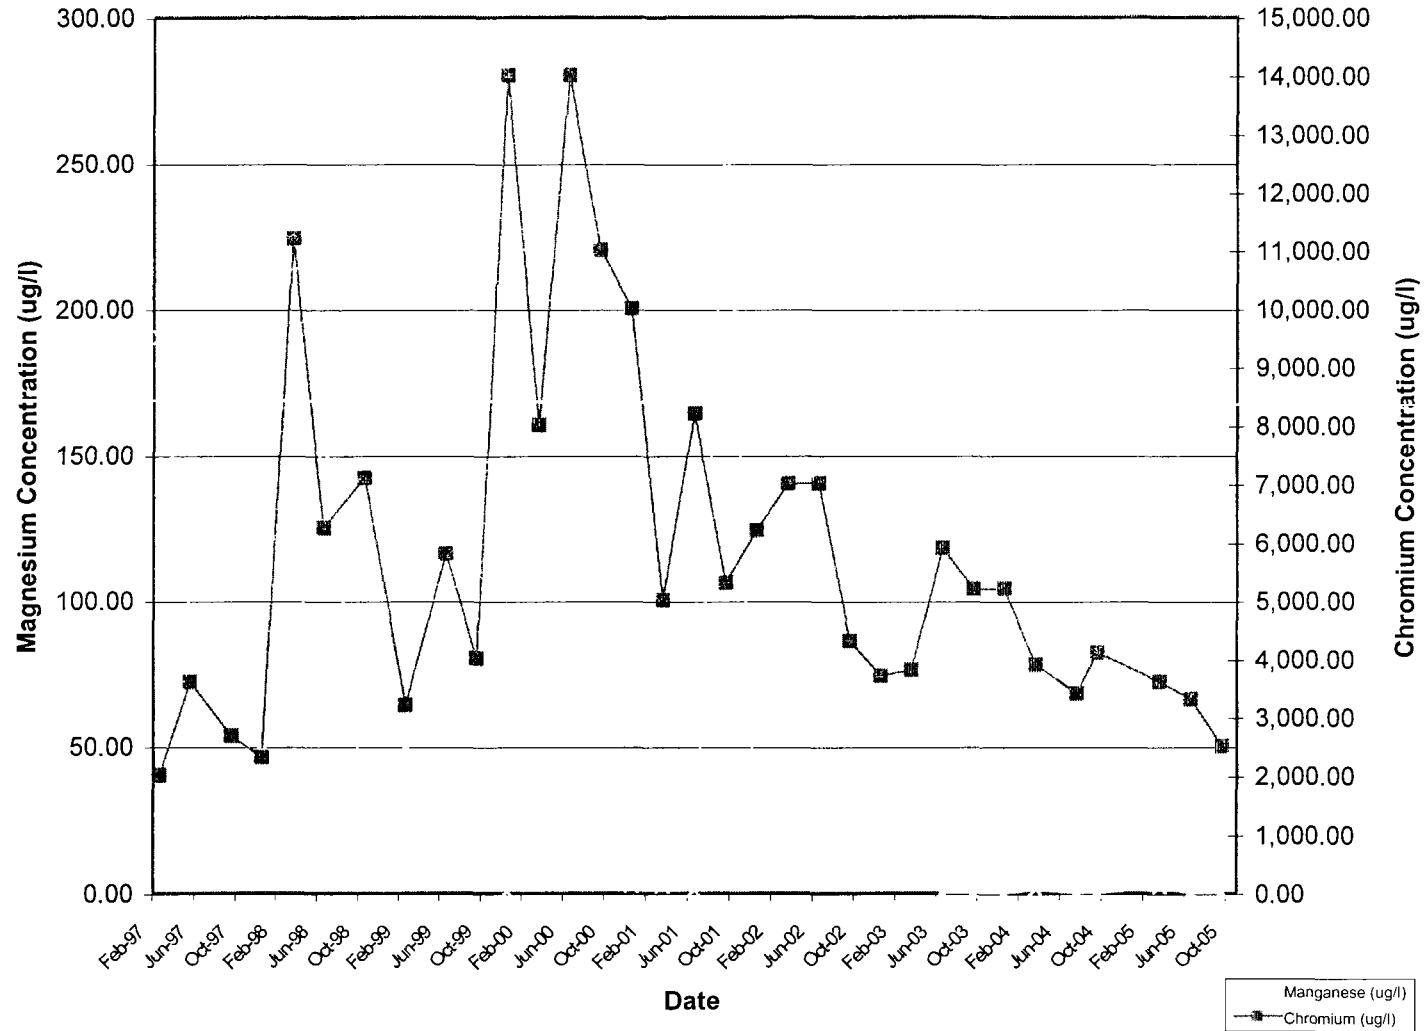
MW-107 / Time vs. Concentration

has exceeded the concentration that represents a HI of one at MW-107. It should be noted that higher levels of chromium may be present at the Mauthe property and will be evaluated with installation of additional wells in former source areas.
